# Recommendations for Improving Energy Efficiency in Quigley Hall

Department of Environmental Science

Allegheny College

April, 2023

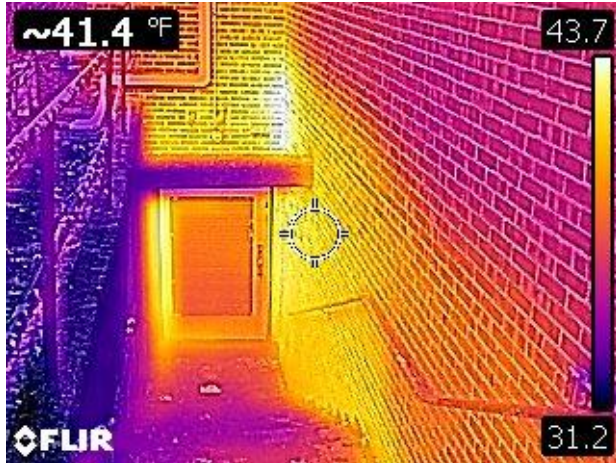
There is one door on the building that leads from the outside to the basement, which is pictured below. This door is very poorly insulated and the IR camera shows a large amount of heat escaping from it and heating the surrounding area. There are small holes in this door intentionally.

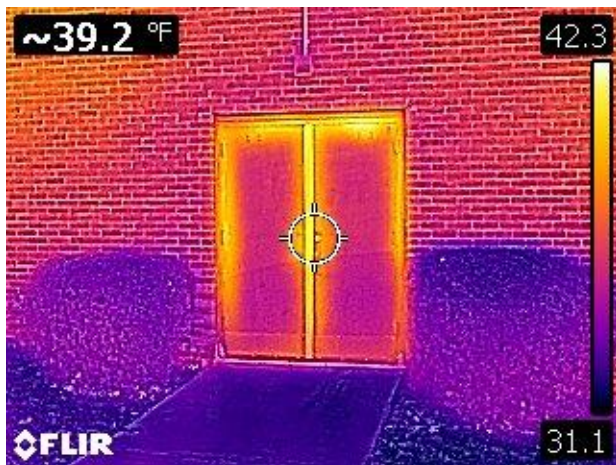
There are two other doors on the building's exterior on the east and west sides of it. These doors are both made out of metal and are poorly insulated. There are visible cracks both around and between the doors that are large enough to see through, and heat can be seen escaping from them in the picture below.

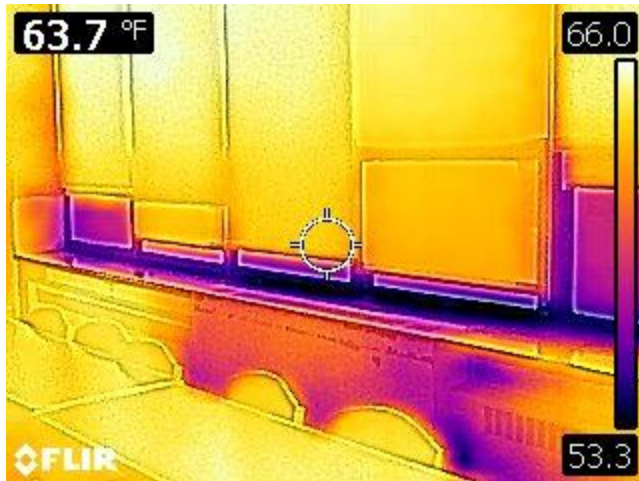
The building has many windows on all sides of it that make up a large amount of the building's surface area. These windows are single pane and have metal around them. The IR picture below shows a classroom window, which is colder than the rest of the classroom and indicates that it does not have great insulation.

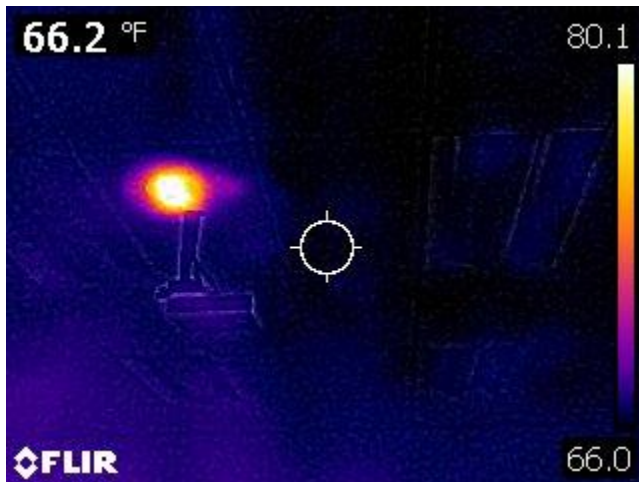
Another possible improvement that could be made to the building is replacing some of the lights and electronics. The lights are mostly LED, but there are still some T5 lights that could be changed to LED to reduce their energy consumption. Some electronics and devices such as computers are older and could potentially be replaced. The image below shows a large amount of heat around a projector, which indicates that it is using a large amount of energy.
